# **ADELAIDE IN-DEPTH ACCIDENT STUDY**

1975-1979

## **PART 5: COMMERCIAL VEHICLE ACCIDENTS**

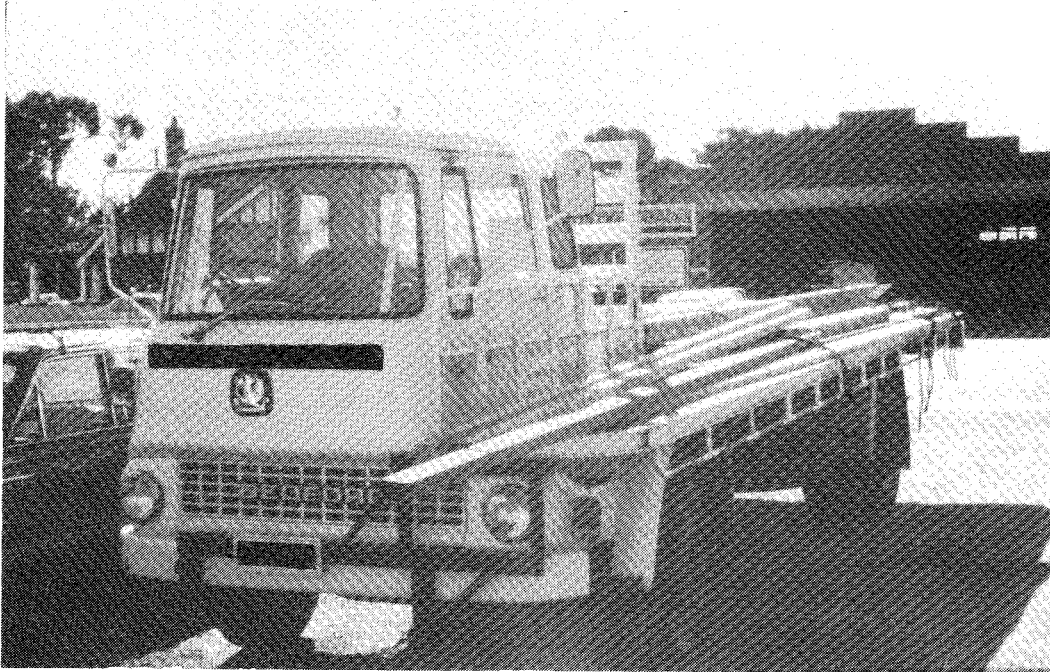
FIGURE 1: Lengths of timber slid forward under emergency braking. Accident 111.

The failure to retain a load under braking was the direct cause of serious injury to the driver of a car in Accident 111, as described in Section 5.2.

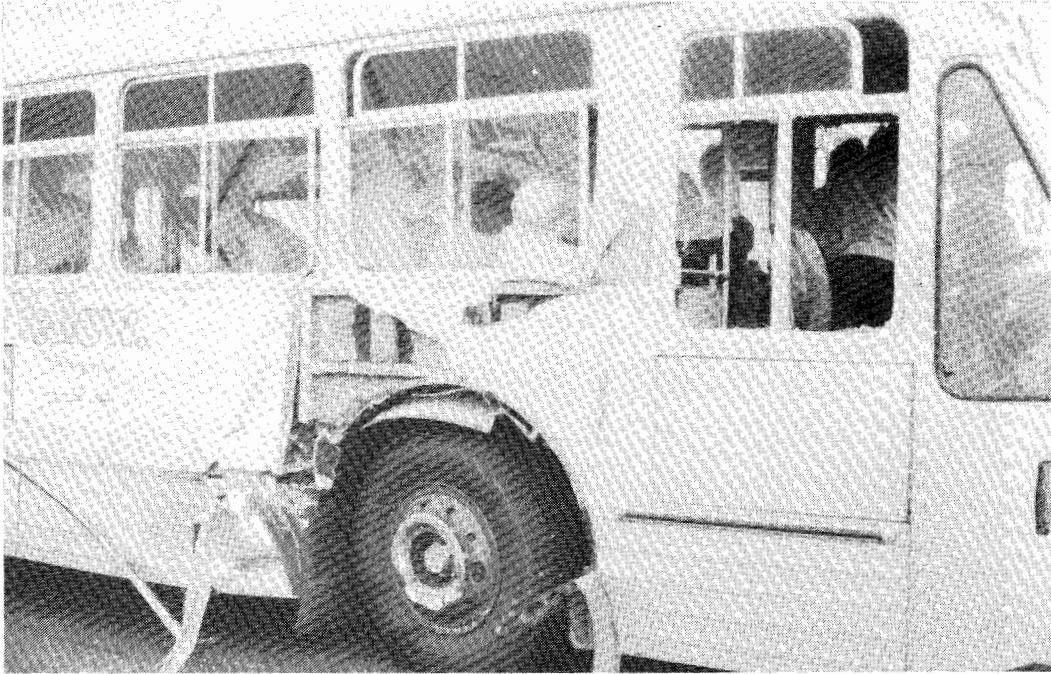
FIGURE 3: Damage to bus in Accident 210.

Despite the fact that the bus was struck by a heavy vehicle the collision was not very severe because the truck, or prime-mover, was travelling slowly (the front wheels of the prime-mover were dragged sideways as the front corner snagged on the side structure of the bus). Consequently few of the bus occupants were injured at all, and those who were sustained relatively minor injuries, except for the person who was concussed. Even so, two of the passengers were injured when they were thrown against the tubular steel handrails or seat frames. The needlessly hazardous nature of such fittings has been noted previously (Hoffmann, 1975).

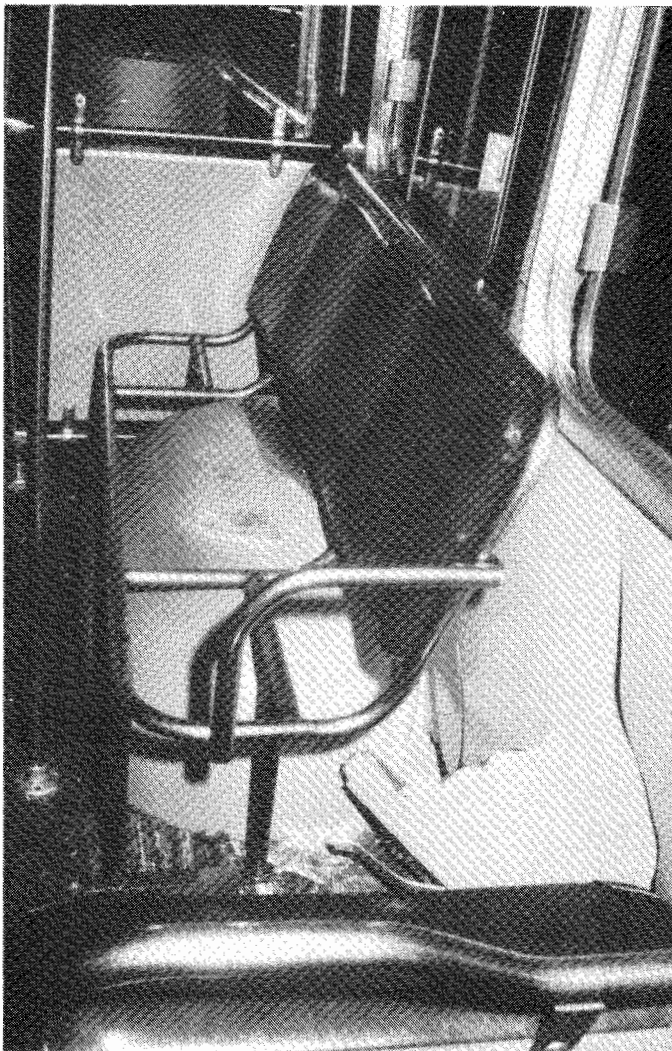
FIGURE 4: Damage to the interior of the passenger compartment of the bus in Accident 210.

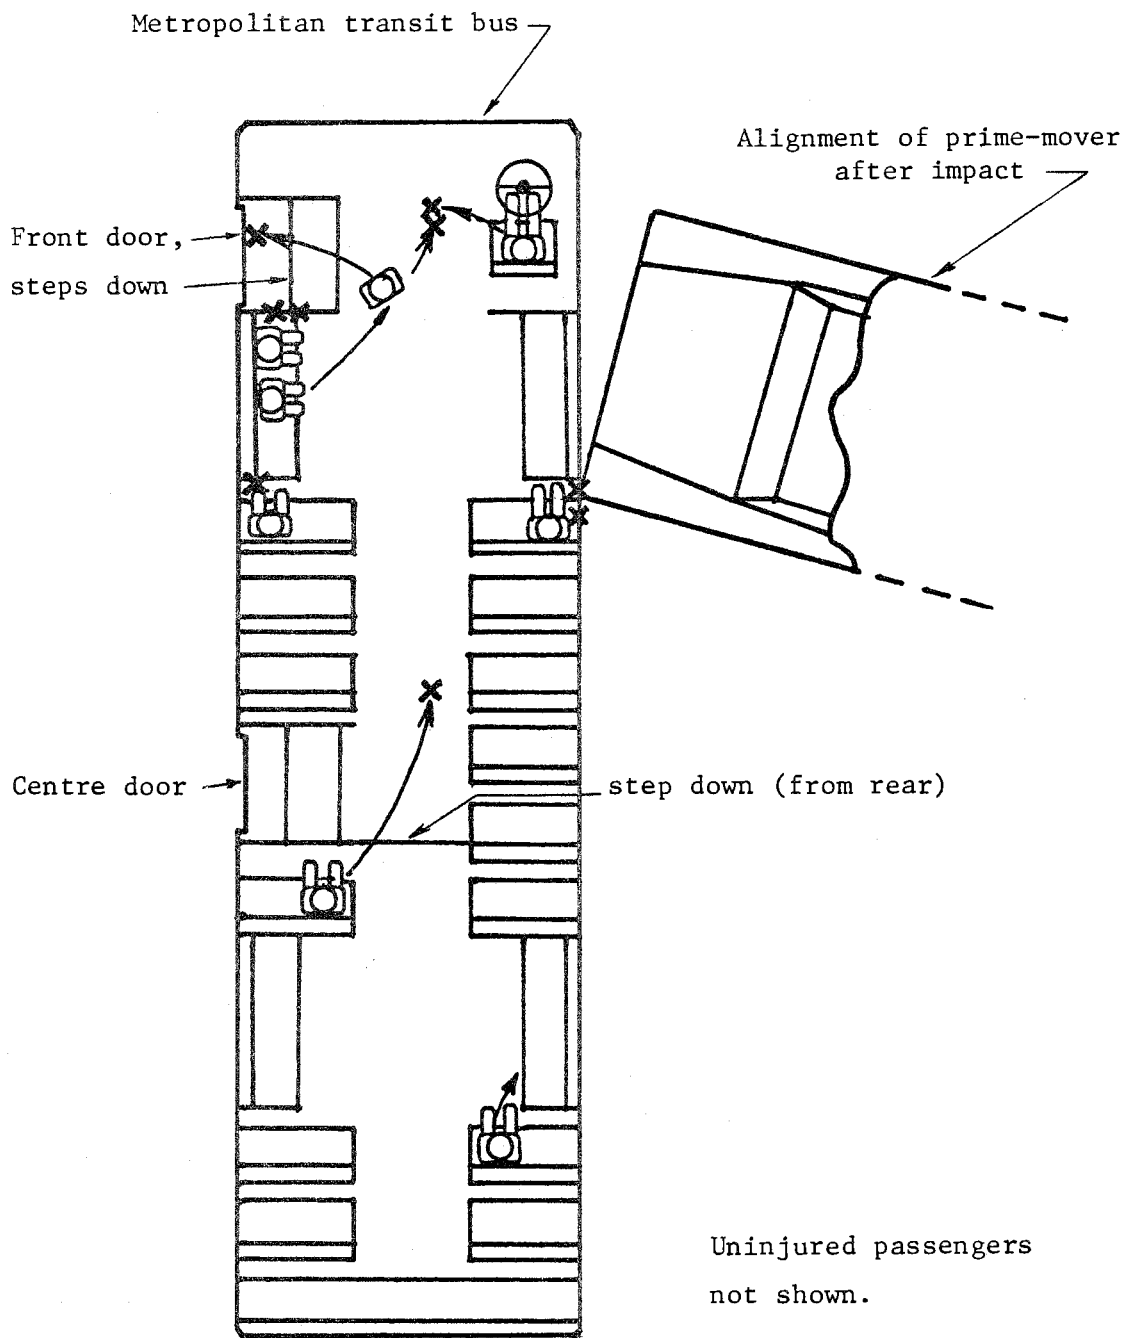
FIGURE 5: Movements of Injured Bus Occupants (Accident 210).

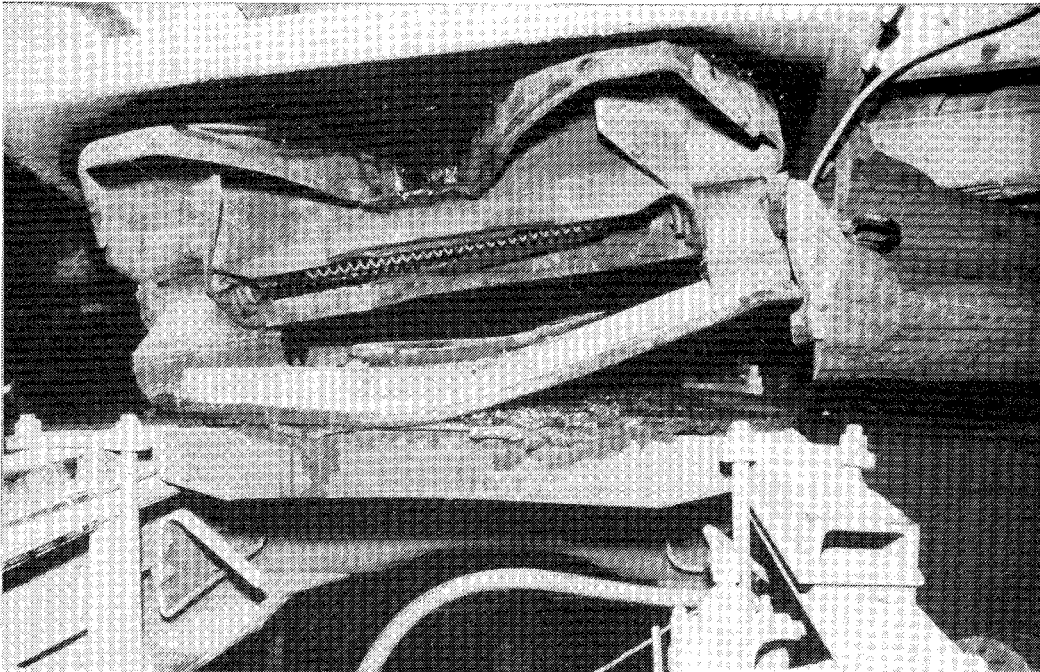
FIGURE 6: Fifth-wheel assembly deformed when load shifted and semi-trailer rolled over. Accident 013.

One other accident (013) resulted from the load shifting on a semi-trailer, this time not as a consequence of heavy braking. This accident has been noted earlier in this report, but a more detailed description of the load is appropriate here: paper bags were packed in small bundles and stacked on pallets, which were retained by gates, ropes and tarpaulin. On entry to an off-camber right hand corner at low speed, the lack of friction between these packages allowed the top of the load to move outwards and this shift continued to the extent that the inside wheels of the trailer lifted and both the trailer and prime-mover rolled over onto the left side. The fifth wheel assembly on the prime-mover was damaged during the rollover (Figure 6). The dangerous instability of this load can be further appreciated when it is realized that the driver was intending to travel interstate but had completed less than 20 kilometres of his journey. He stated that cargoes such as this were prone to shifting and that subsequent roll-overs were not unknown.

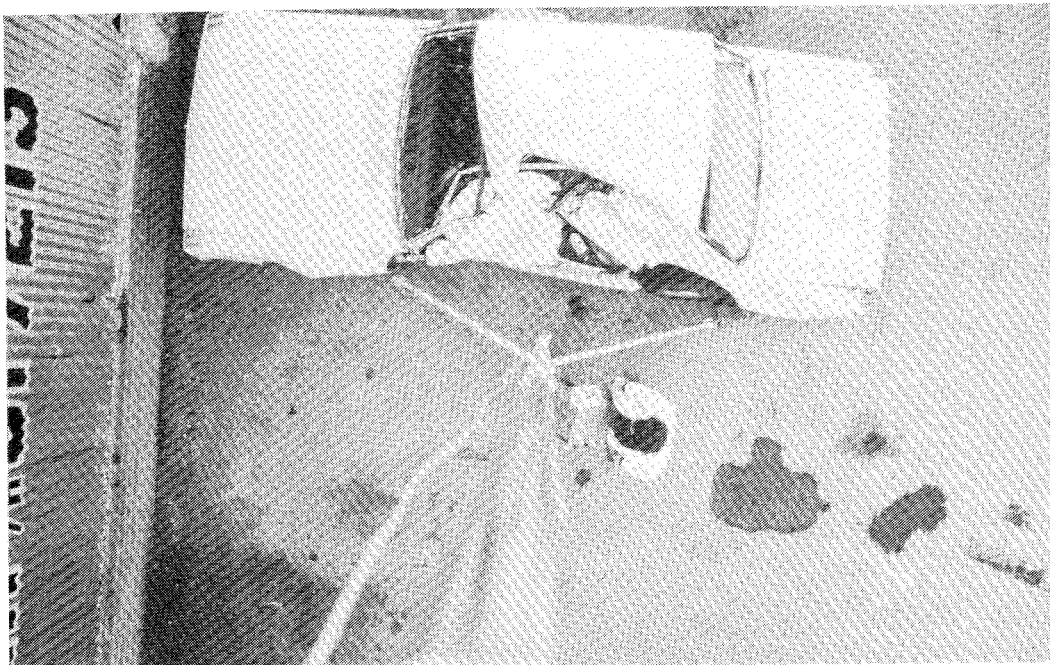
FIGURE 7: Damage resulting from a collision with a truck of the type shown in Figure 8. Accident 076.

The extent of the damage which can result from a collision between a truck and a car is illustrated in Figure 7. The type of striking vehicle (but not the actual vehicle) is shown in Figure 8. The car had turned right, across the path of an oncoming truck which was travelling at a speed of about 60 km/h on impact (Accident 076). Note that, as shown in Figure 7, the main force of the impact was located on the side of the car above

*The Advisory Committee on Vehicle Performance review the desirability of regulating the frontal design of heavy vehicles, including the design of components such as bull-bars, so as to ensure that the damage inflicted in a collision on passenger cars and on other road users, including cyclists and pedestrians, is minimized.*

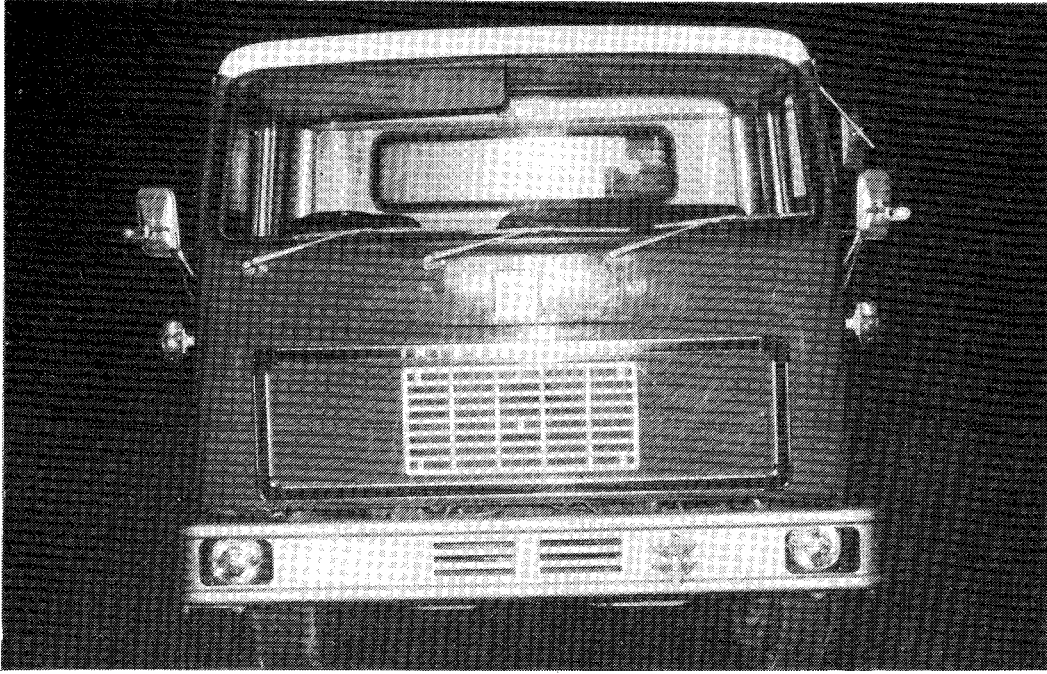
FIGURE 8: Truck of the type involved in Accident 076 (see Figure 7).

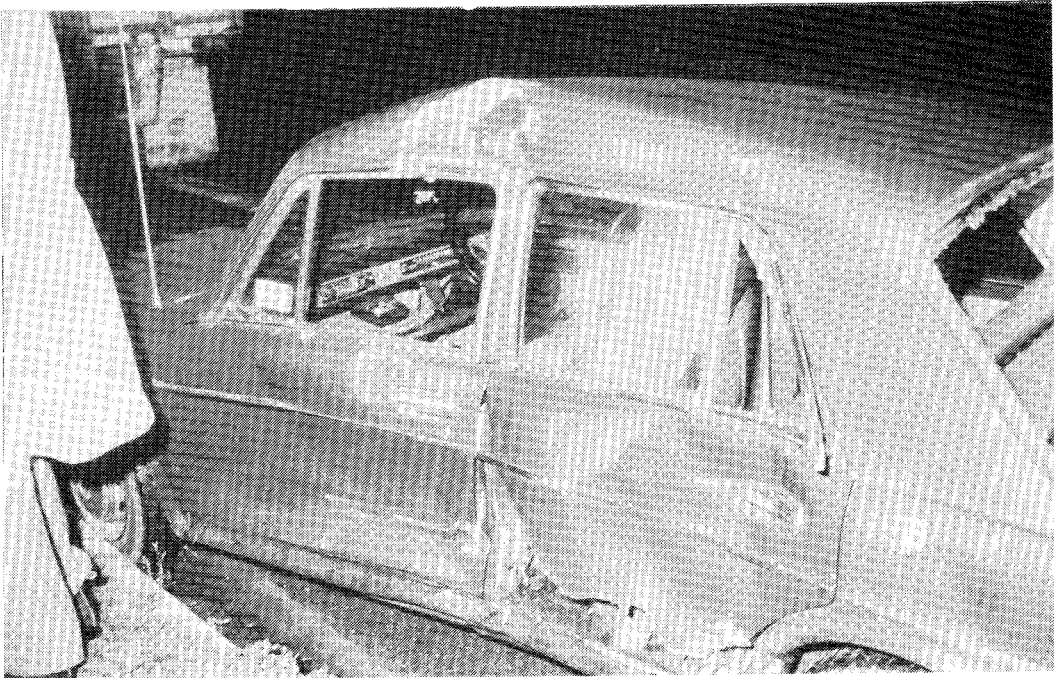
FIGURE 9: Damage resulting from collision with truck shown in Figs. 10 and 11. Accident 123.

In a similar collision the damage to the car was far less severe, partly because the heavy vehicle was fitted with a bull bar which extended down below the standard bumper bar (Accident 123, Figures 9 to 11). The force of the impact was still above the level of the door sill of the car, but the lowest part of the bull bar hit the left rear wheel of the car, thereby pushing the car sideways without loading the upper body structure of the passenger compartment. Two other factors distinguish this accident from the previous case: the car appears to have been more nearly side on to the front of the heavy vehicle in Accident 123, and the speed of the truck on impact may have been slightly less than in Accident 076.

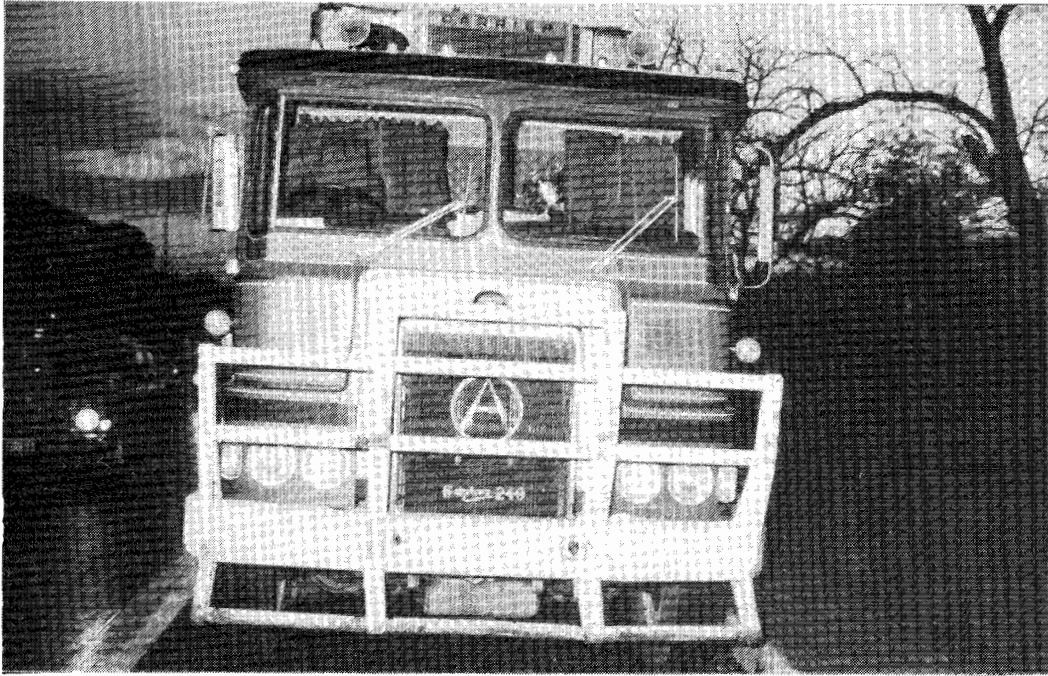
FIGURE 10: Truck involved in Accident 123 (see Figure 9).

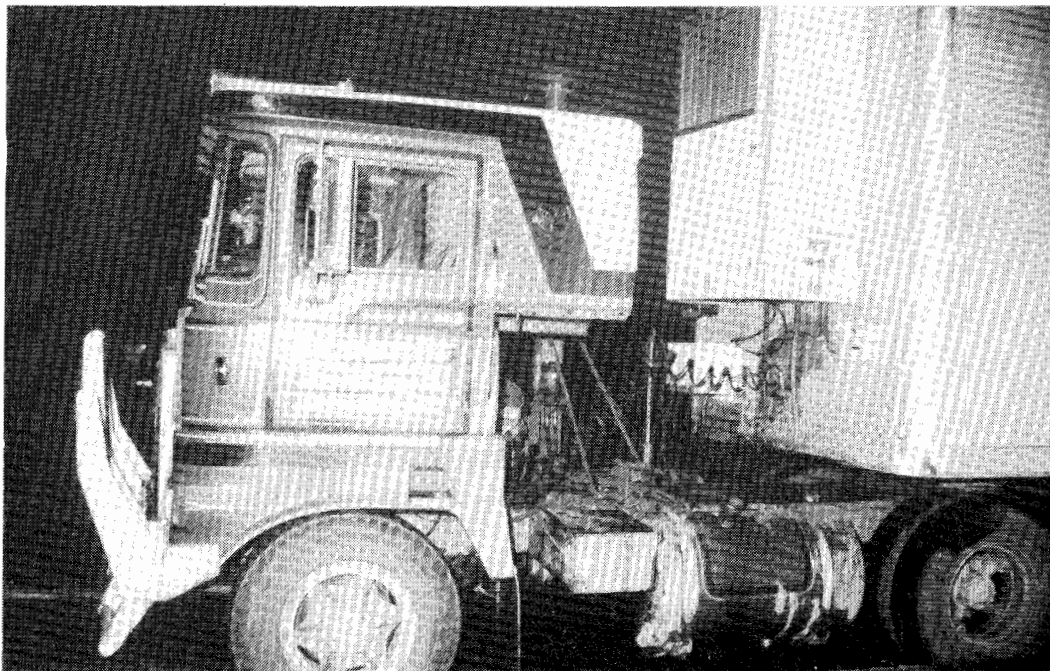
FIGURE 11: Truck involved in Accident 123 (see Figure 9).

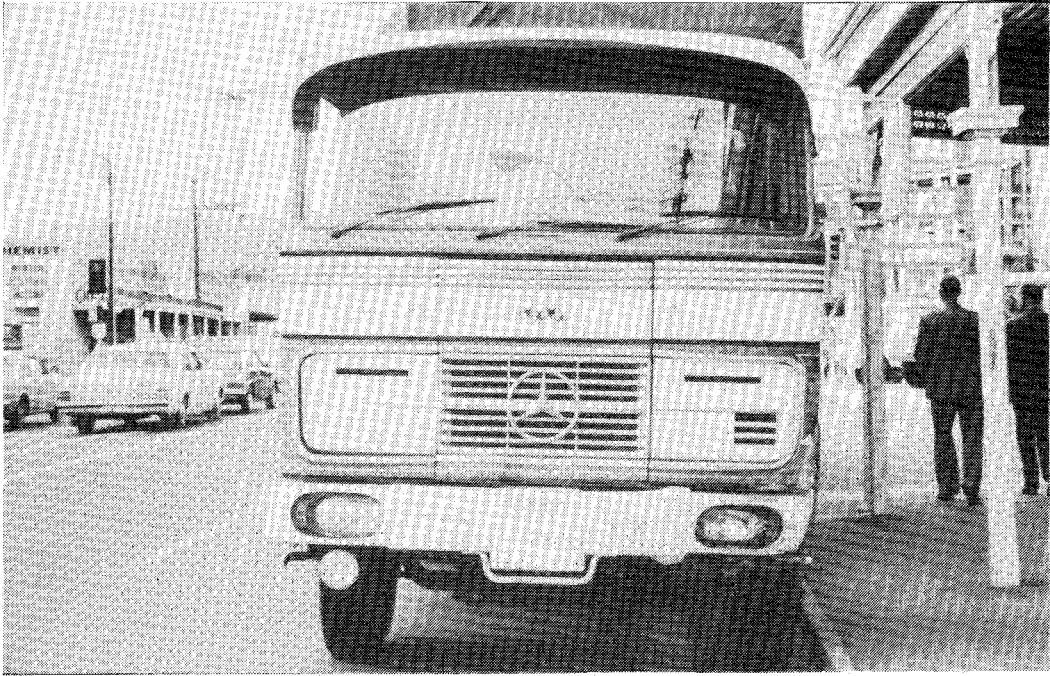
FIGURE 12: Truck involved in Accident 170. Note damage to left end of front bumper bar. (See Figure 13).

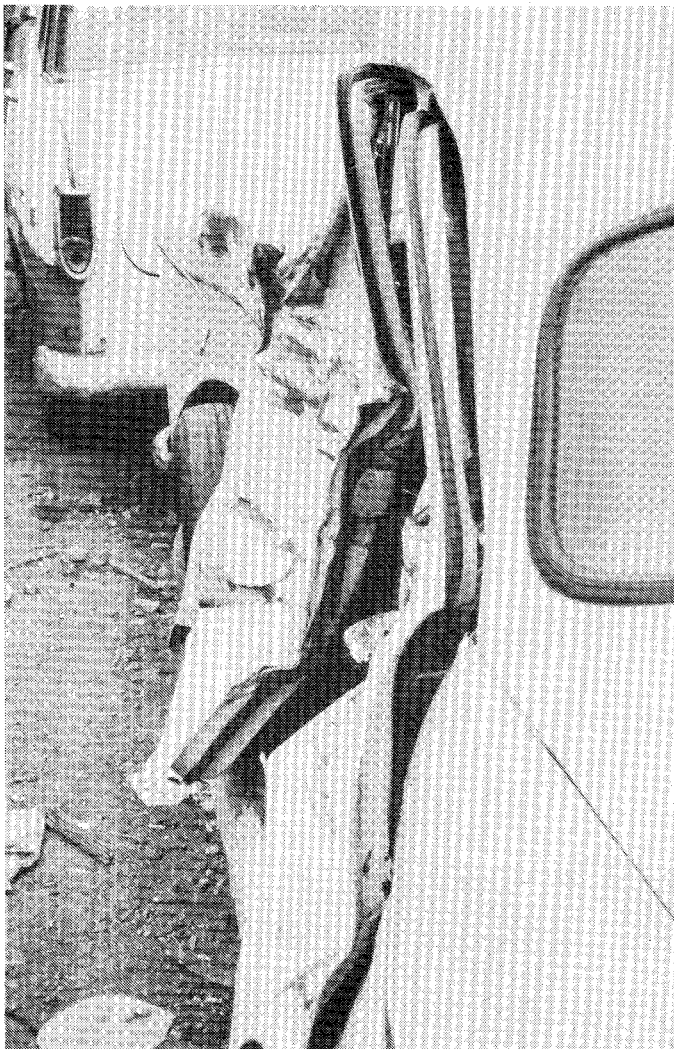
FIGURE 13: Damage to car in Accident 170 (see Figure 12).

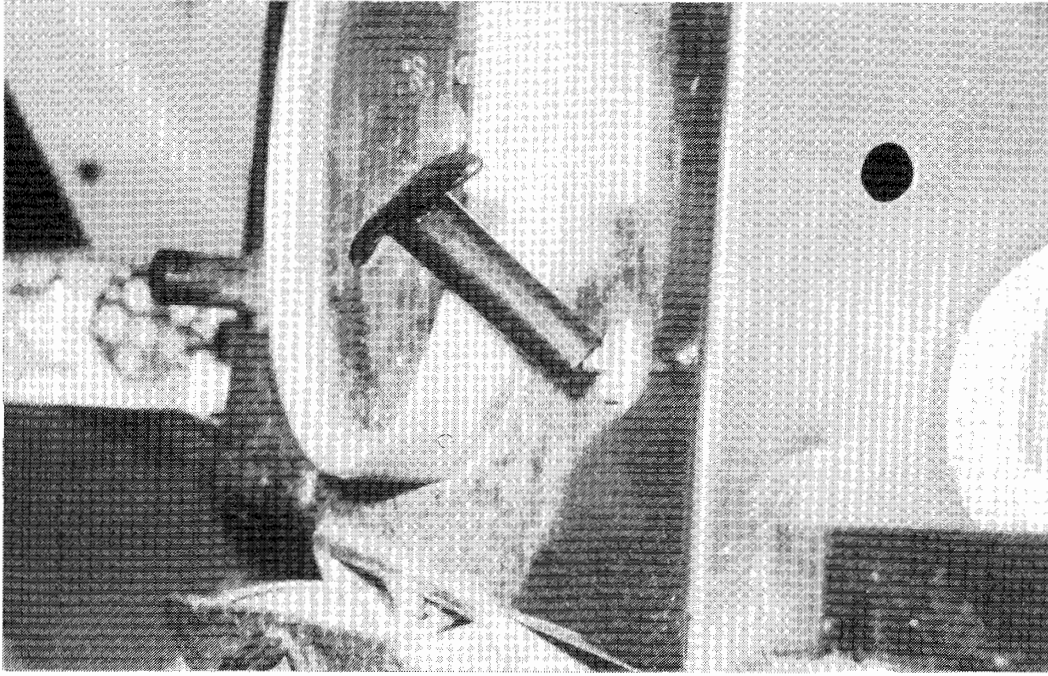
FIGURE 14: Damage to knob on instrument panel of Mini Moke due to impact by driver's knee. Accident 129. (See Figure 15).

In Accident 129, in which a Mini Moke crashed into the back of a parked car, the driver was not wearing the lap seat belt because she was concerned that if she did so she would be at greater risk of sustaining a facial injury in a frontal impact. The validity of this opinion is arguable, the alternative total lack of any restraint not being a desirable option, but this driver said that she always wore the more common lap and sash belt when it was available in other cars. In this accident she was thrown forwards in the impact, striking her knees on the instrument panel on the left (Figure 14) and on the metal edge of the parcel shelf on the right, sustaining the contusions and abrasions shown in Figure 15. She then pivoted forwards and to her left, striking her face on the rear vision mirror. This vehicle was manufactured in 1975, and so was required to comply with ADR14 which specifies, inter alia, that the internal rear vision mirror break away from its mounting when struck, which it did not do in this accident. Indeed it is difficult to see how it could have broken away because the mirror is located almost touching the windscreen (Figure 16). This meant that the driver's face, on hitting the mirror, immediately wedged the mirror against the windscreen. The glass in the mirror broke, and the driver sustained lacerations to the left side of her face.

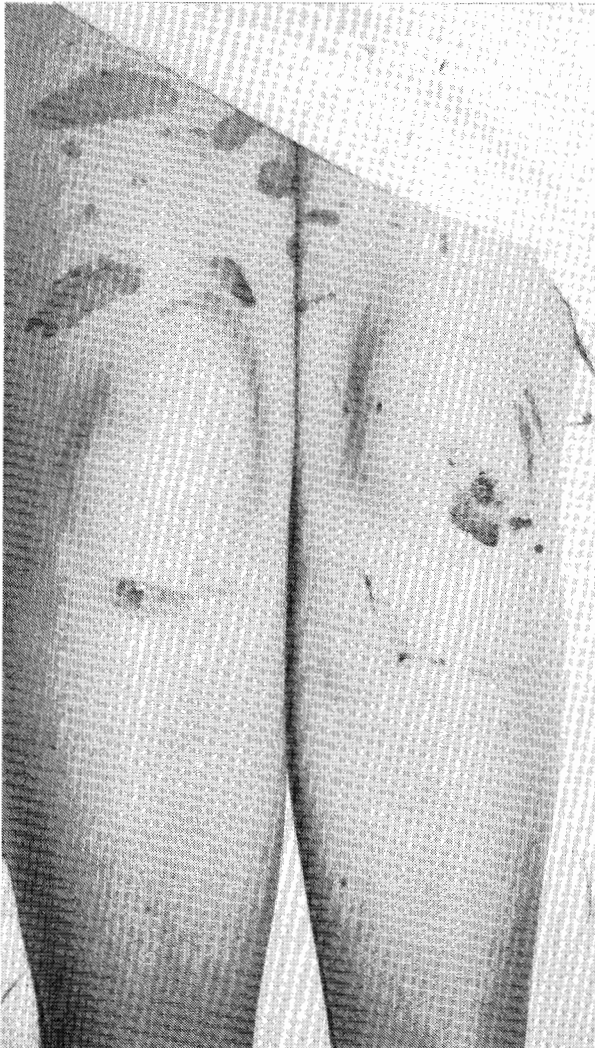
FIGURE 15:  
Injuries to driver's knees due to striking the instrument panel area of a Mini Moke (see Figure 14).

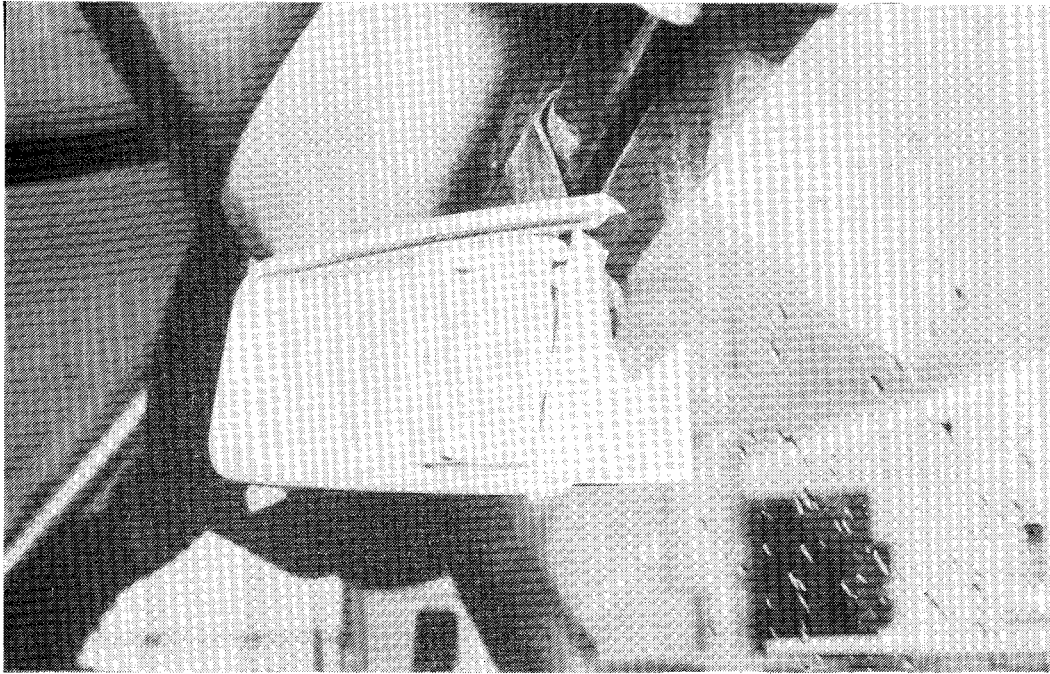
FIGURE 16: Rear vision mirror of Mini Moke after being struck by driver's face. Accident 129.

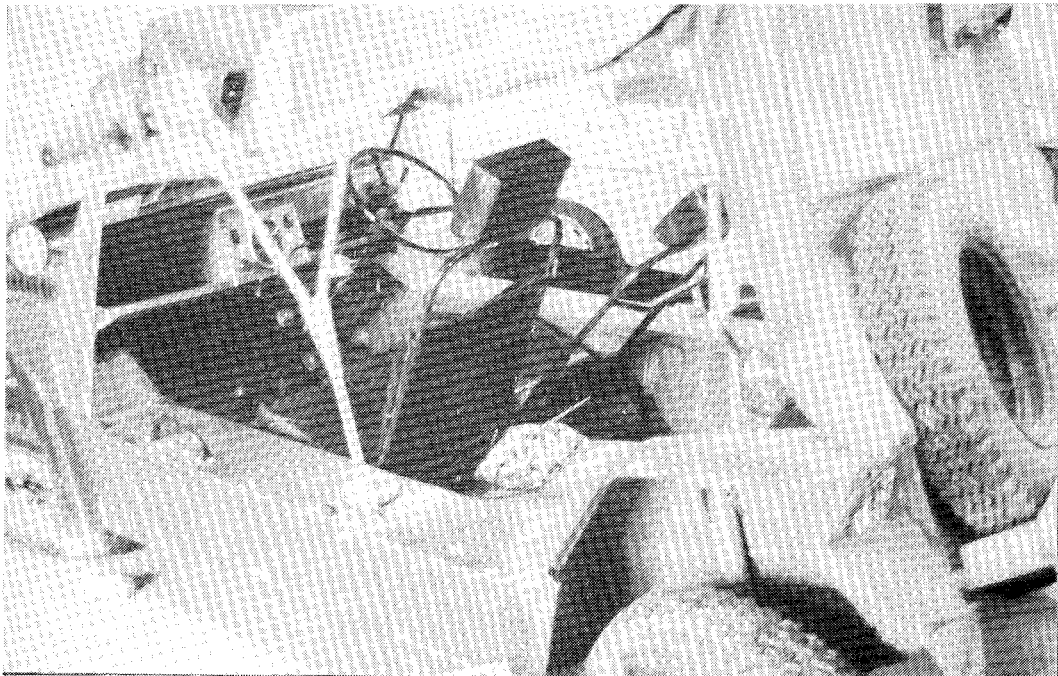
FIGURE 17: Mini Moke in Accident 233. Note damage to back of driver's seat.

The second Mini Moke in this survey was, as has been noted, parked at the side of the road with a person seated behind the steering wheel (Accident 233). When the Mini Moke was hit by a car which was spinning out of control the person in the driver's seat was ejected, after striking his legs and ankles on the parcel shelf and bruising his back on the tubular steel frame of the seat when the hammock-type fabric seat back tore away (Figures 17 and 18).

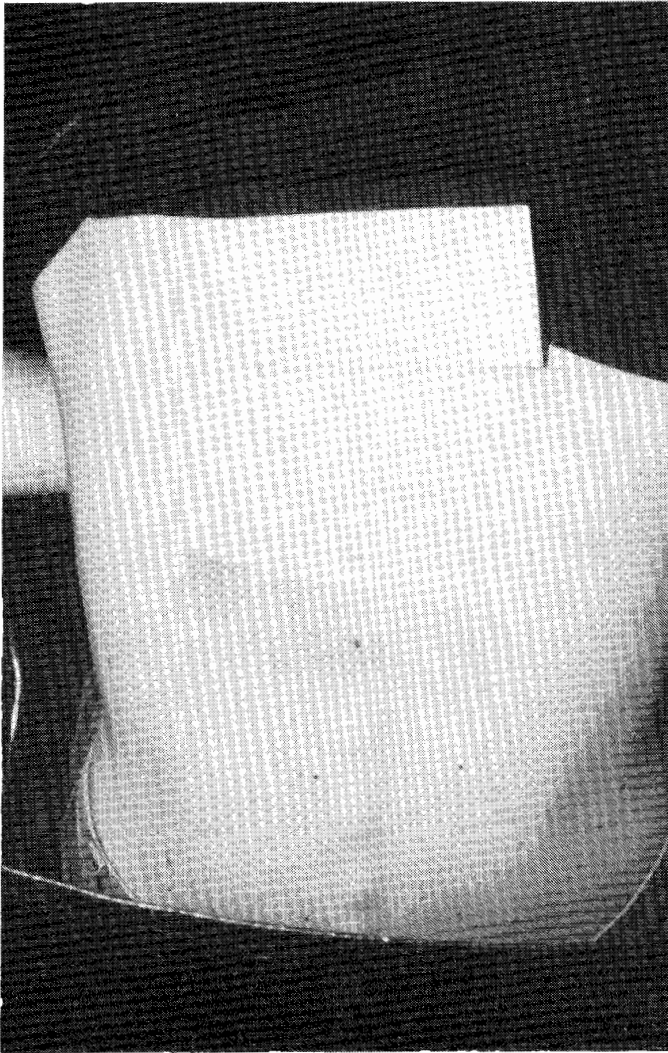
FIGURE 18:

Abrasions to driver's back caused by failure of Mini Moke seat back. Accident 233 (see Figure 17).

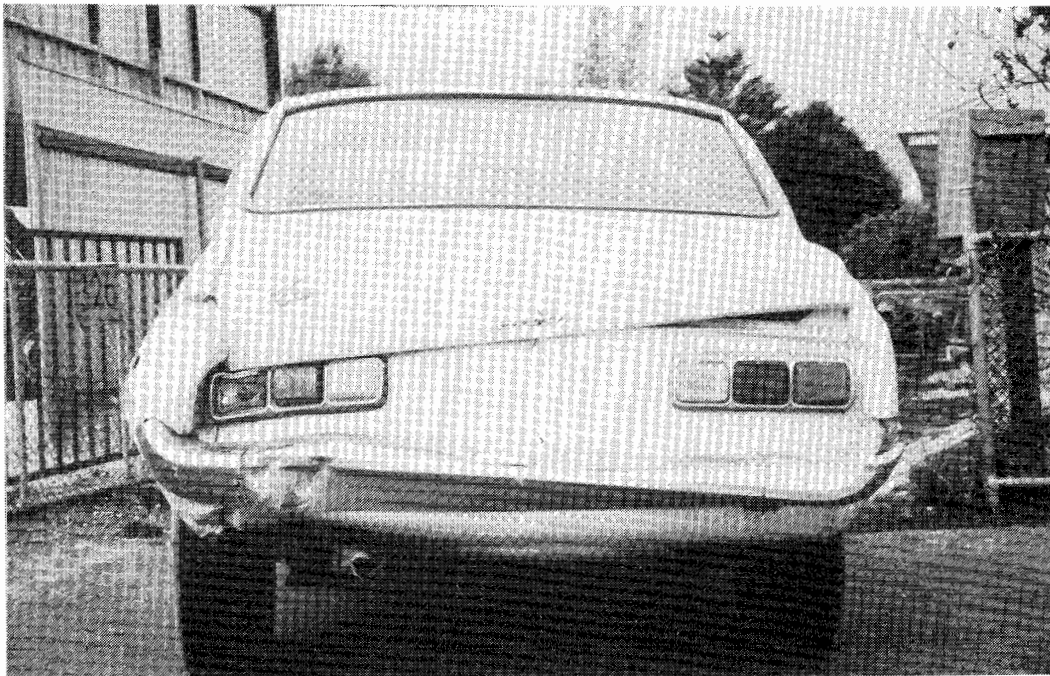
FIGURE 19: Rear of car struck by Volkswagen van. Accident 081.

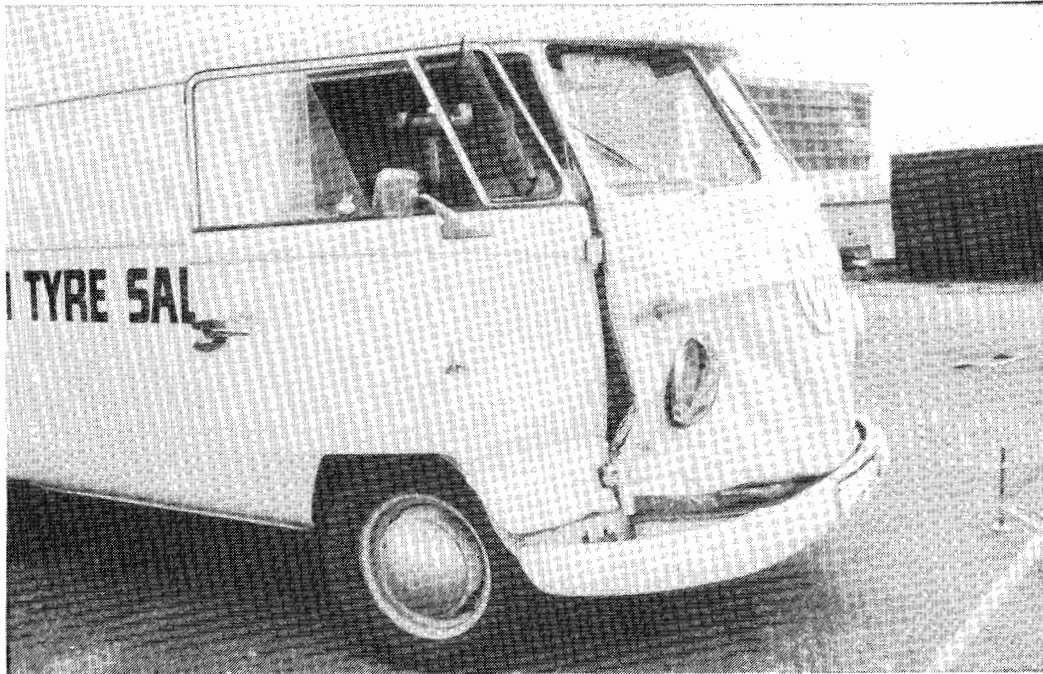
FIGURE 20: Damage to front of Volkswagen van. Accident 081 (damaged area has been forced forwards again to extricate driver).

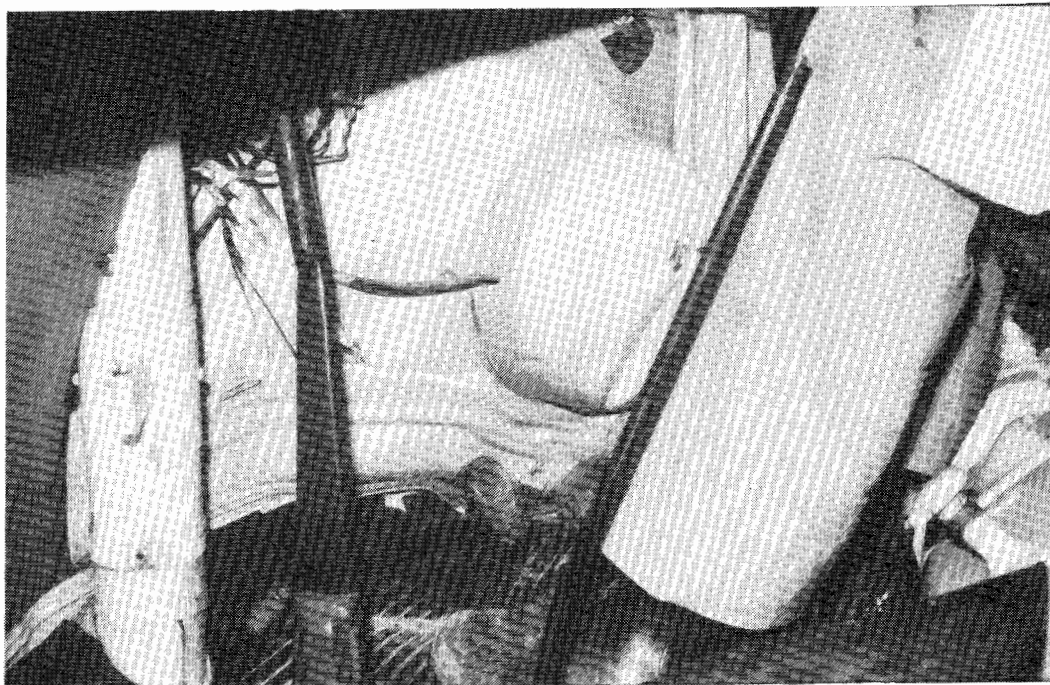
FIGURE 21: Legs of injured driver, trapped in Volkswagen van. Accident 081.

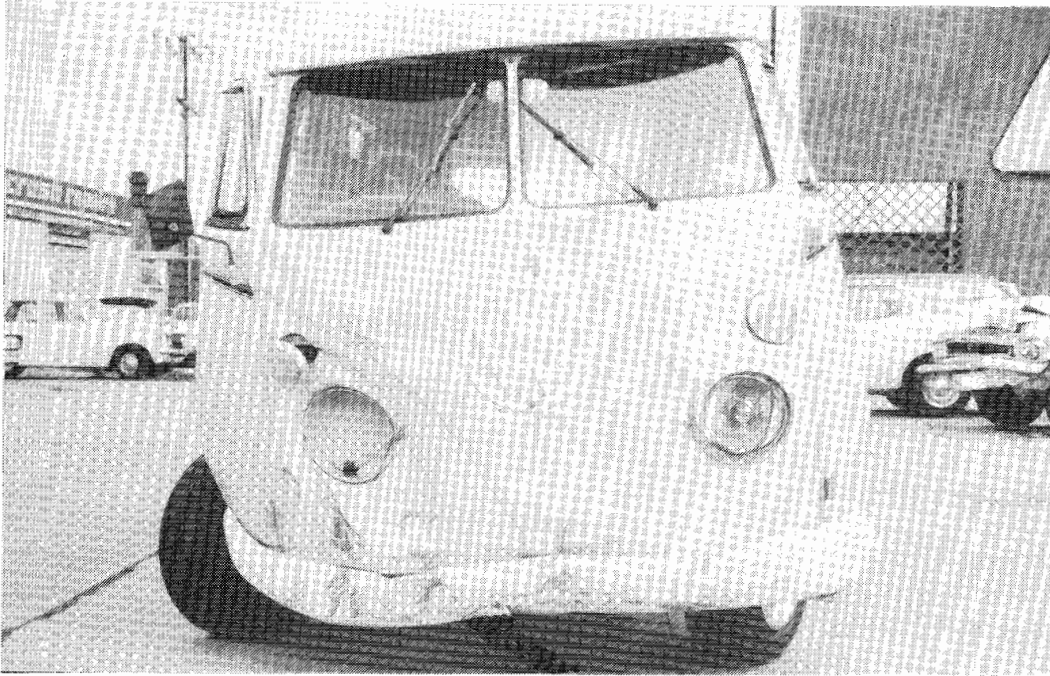
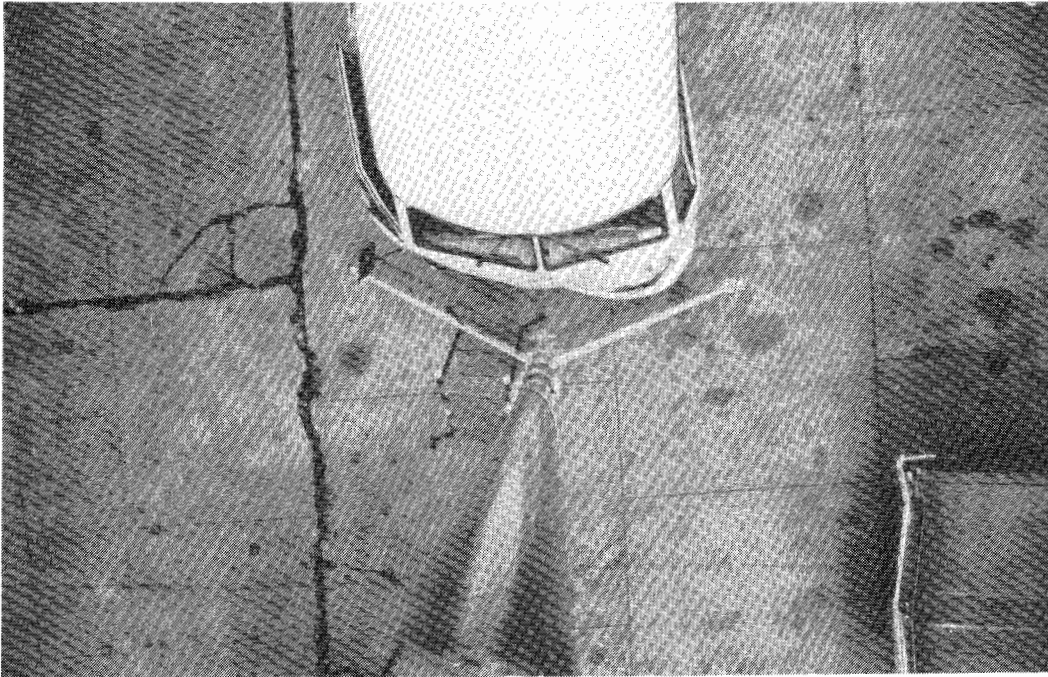
Each of the other two of these Volkswagen Transporters, both Microbuses, struck the side of a car at an uncontrolled intersection. In Accident 130 the driver of the Microbus was wearing a lap and sash seat belt. He was concussed, from hitting his head on the side window glass, and sustained bruises to his legs from striking the steering column and the damaged frontal section of his vehicle. This case differs from Accident 081 in that the front bumper bar, and its supports, took much of the force of the impact (Figures 22 and 23).

FIGURE 22: Damage to Volkswagen van in Accident 130.

FIGURE 23: Damage to Volkswagen van in Accident 130.

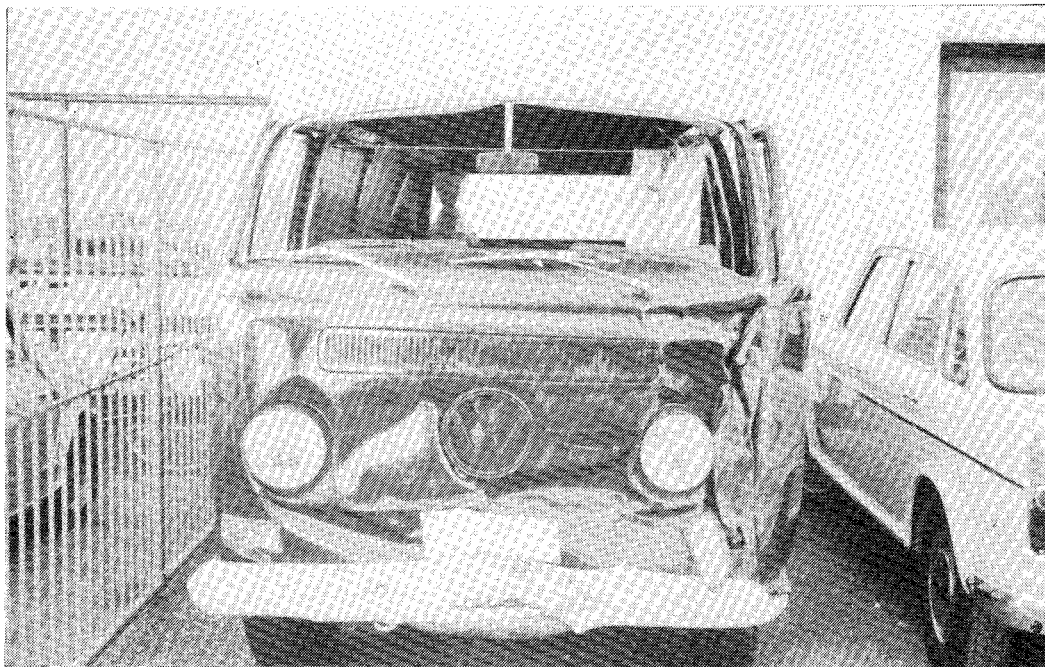
FIGURE 24: Damage to Volkswagen van in Accident 049.

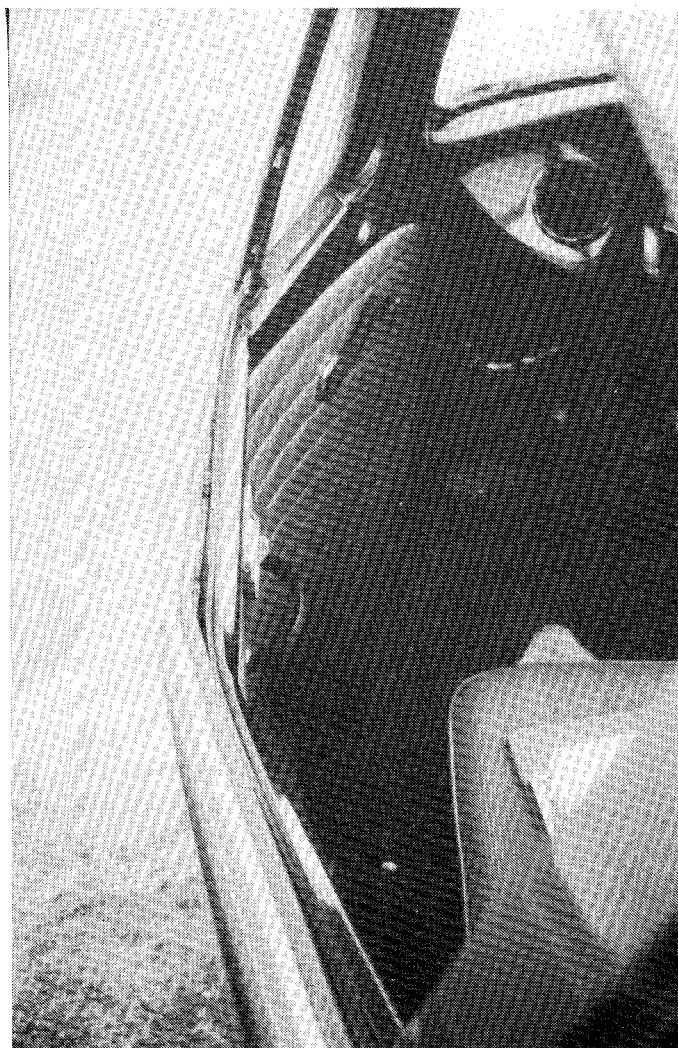
outwards as a consequence of the deformation due to the collision rather than from the left front passenger being thrown against it (Figure 25). This does illustrate the role that longitudinal stiffening of the door structure could play in resisting collapse of the front of the passenger compartment in vehicles of this configuration when involved in frontal collisions.

FIGURE 25:  
Buckling of door of Volkswagen van  
involved in a frontal collision.  
Accident 049.
