Environmental Effects on Recycled Plastics

A thesis submitted for the degree of Master of Engineering Science

APPENDIX D: SEM PHOTOGRAPHS

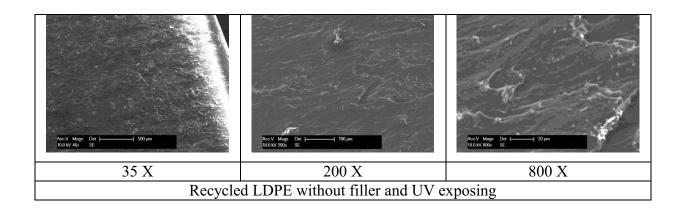
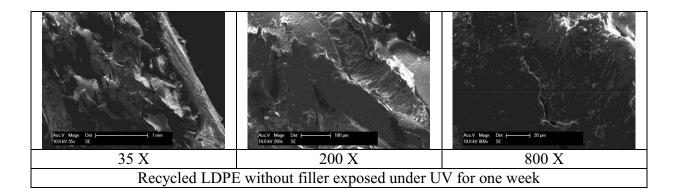
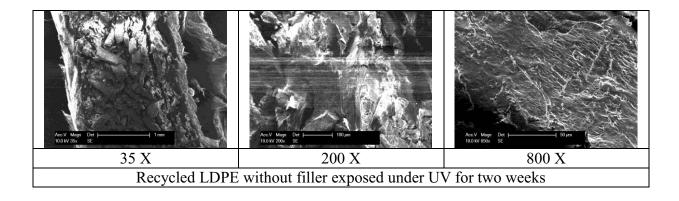
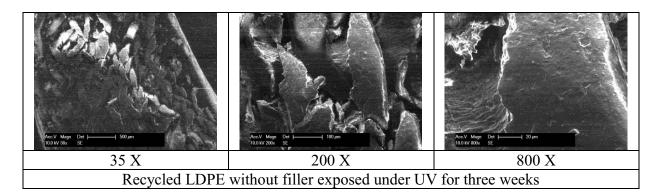
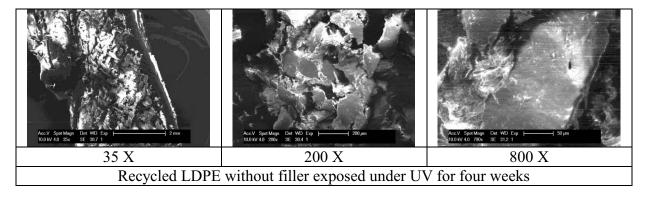
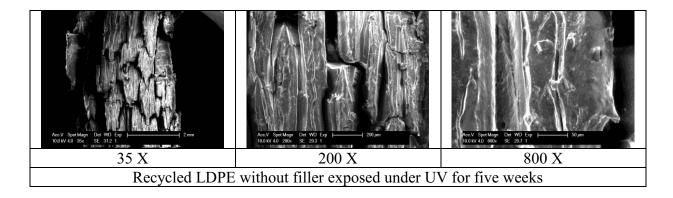
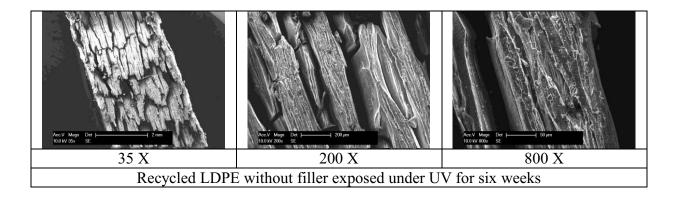
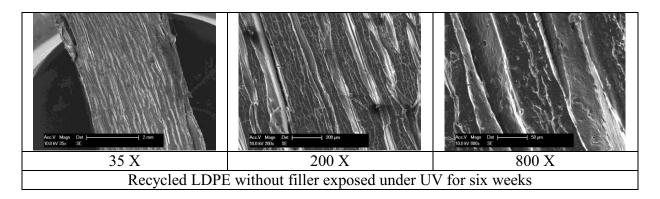
Table D-1. SEM photographs of recycled LDPE without filler under UV exposure

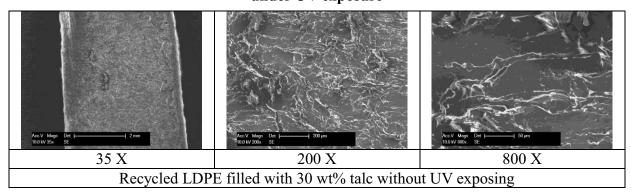
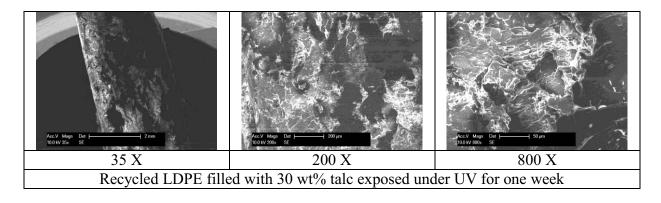
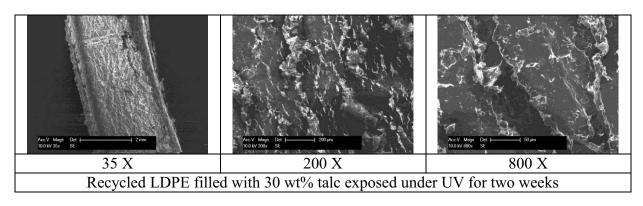
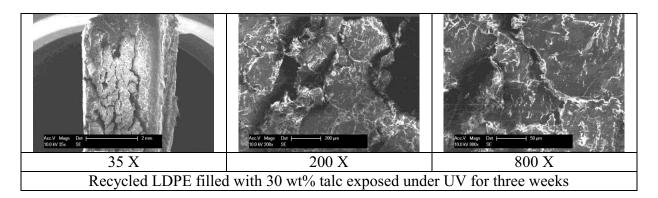
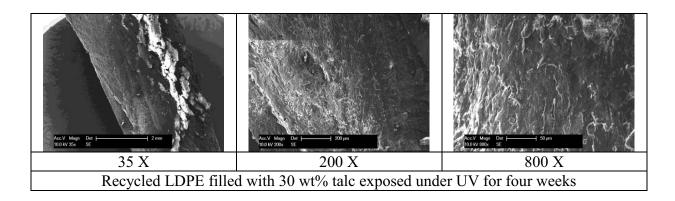
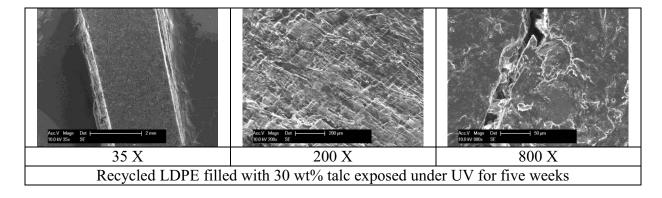
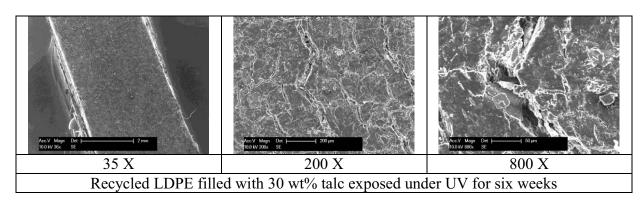
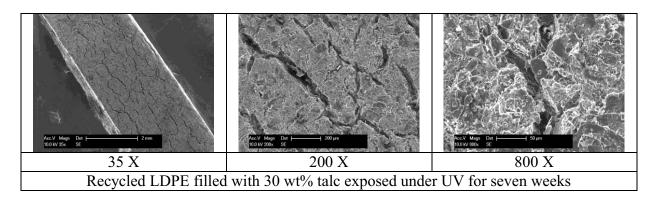
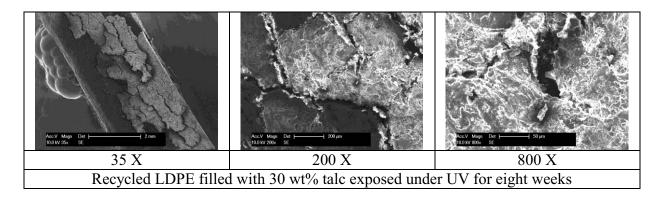
Table D-2. SEM photographs of recycled LDPE filled with 30wt% fine talc under UV exposure

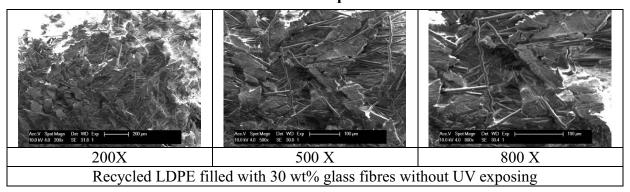
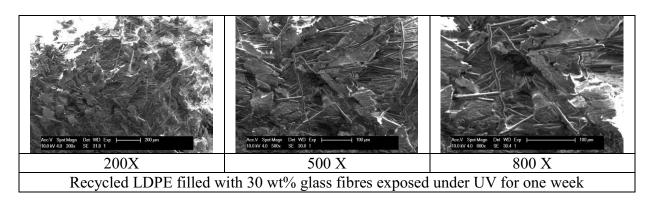
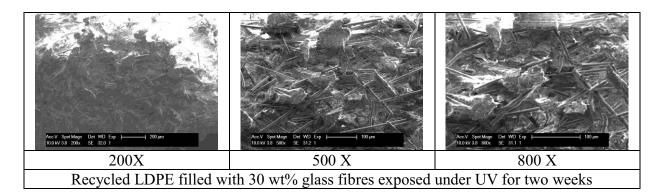
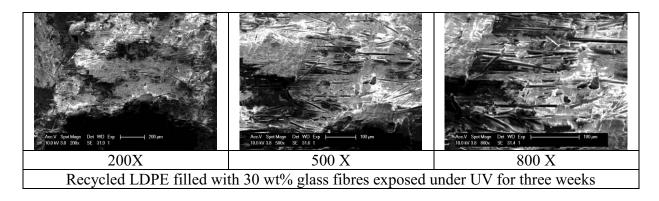
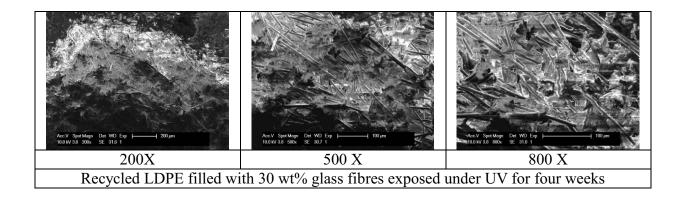
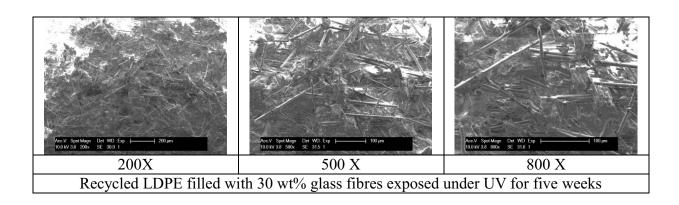
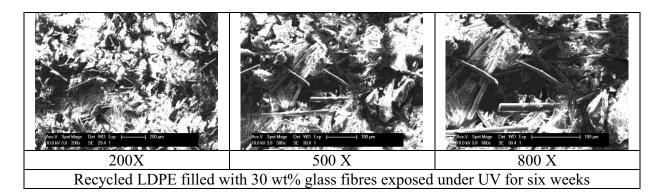
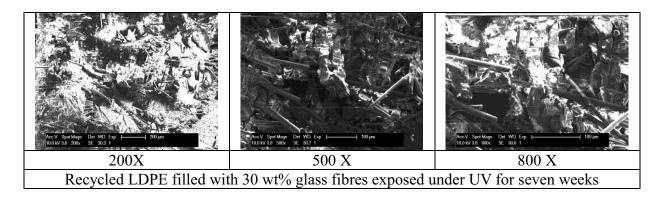
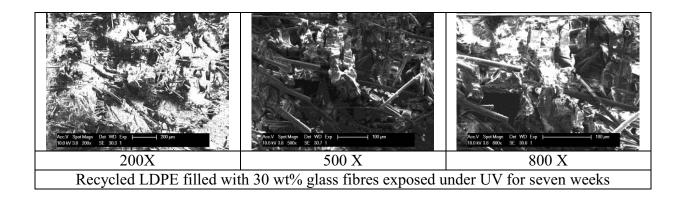
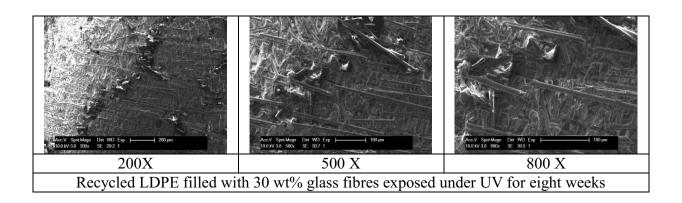
Table D-3. SEM photographs of recycled LDPE filled with 30wt%glass fibres under UV exposure

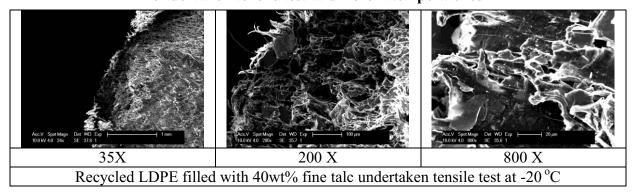
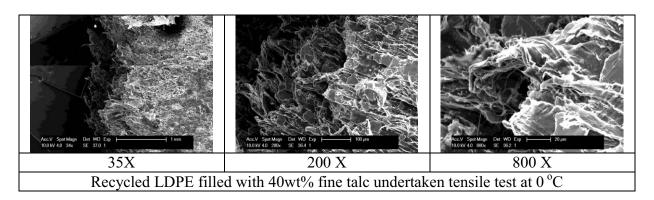
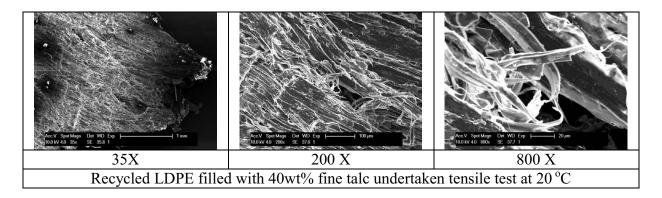
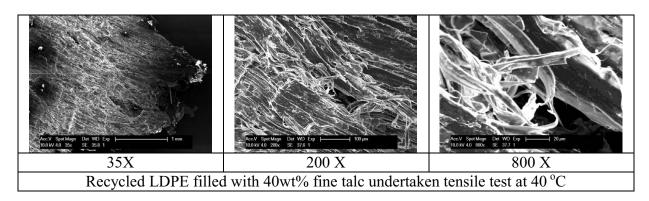
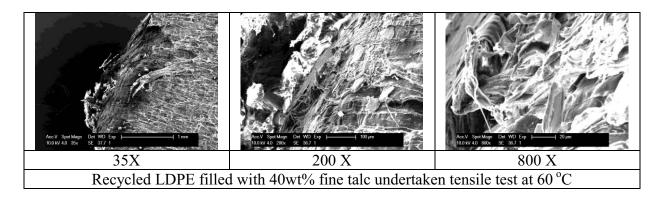
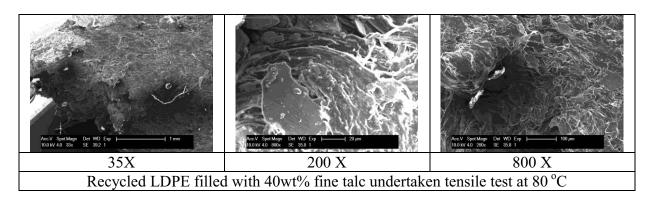
Table D-4 SEM photographs of recycled LDPE filled with 40wt% fine talc undertaken tensile test at different temperatures

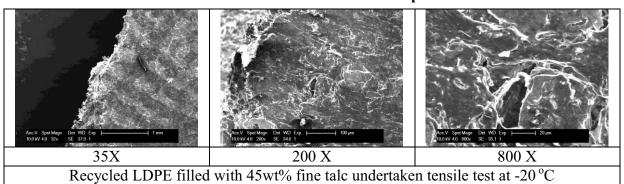
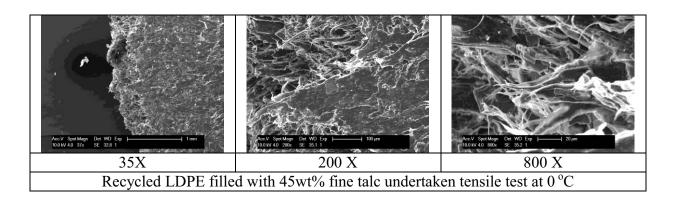
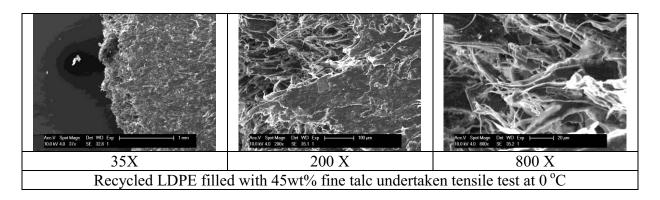
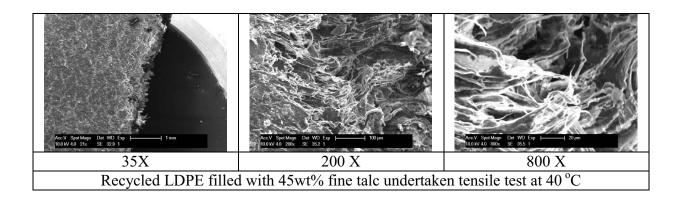
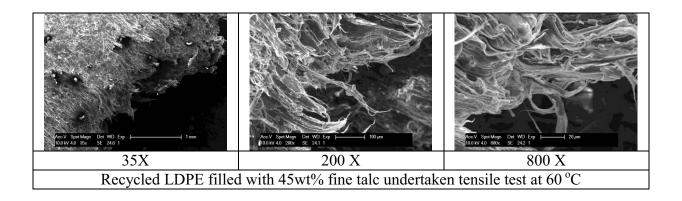
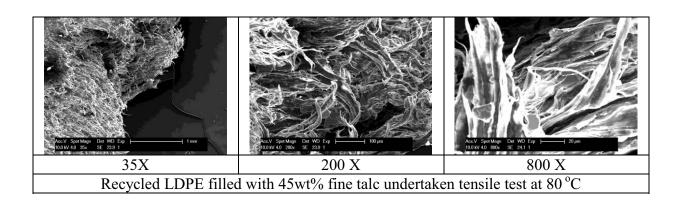
Table D-5 SEM photographs of recycled LDPE filled with 45wt% fine talc undertaken tensile test at different temperatures

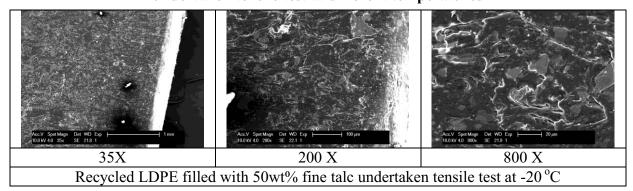
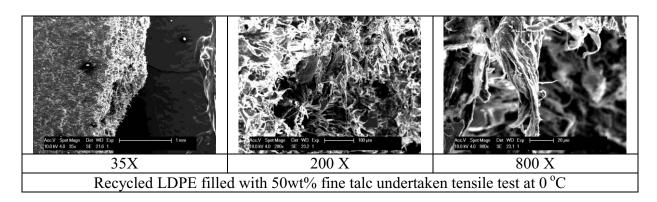
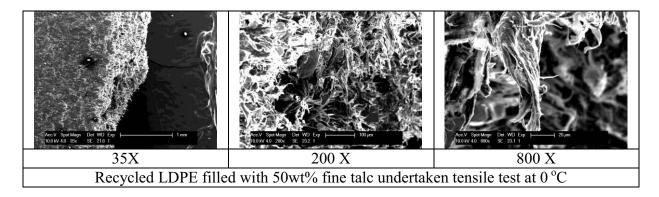
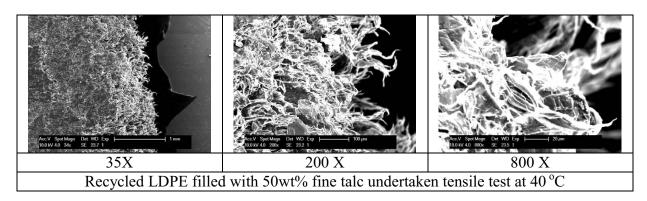
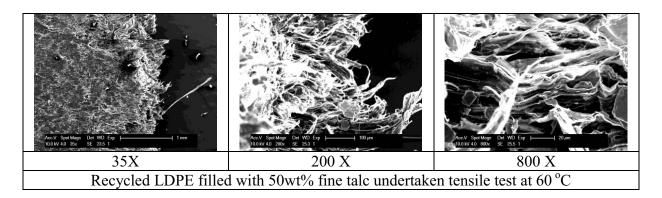
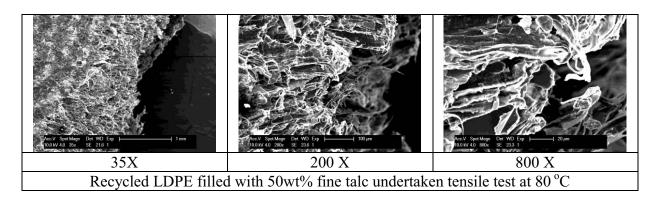
Table D-6 SEM photographs of recycled LDPE filled with 50wt% fine talc undertaken tensile test at different temperatures

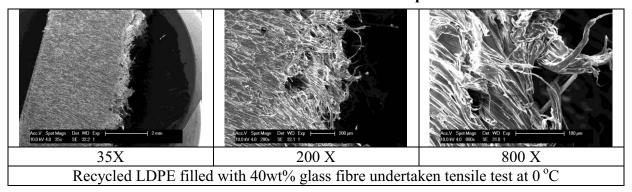
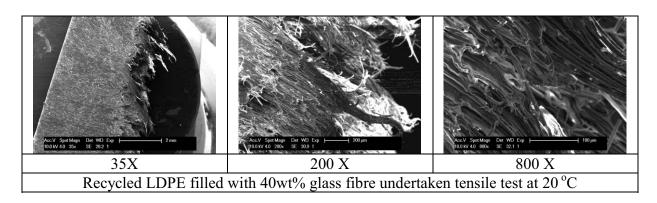
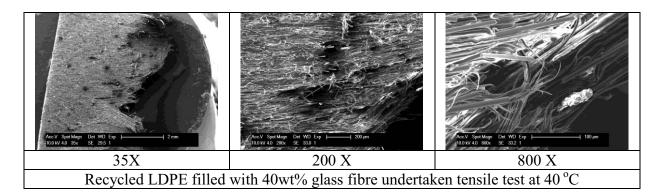
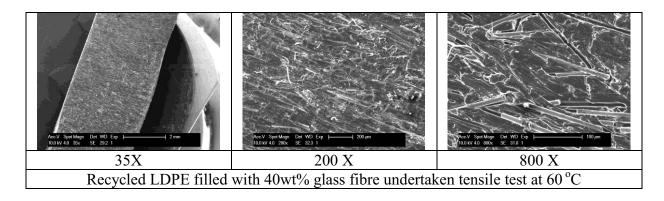
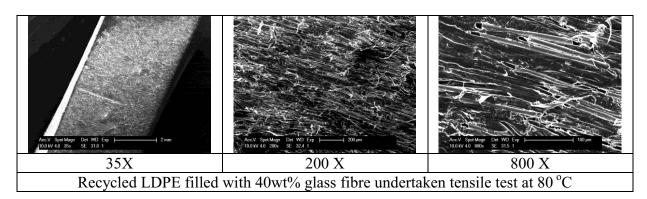
Table D-7 SEM photographs of recycled LDPE filled with 40wt% glass fibre undertaken tensile test at different temperatures

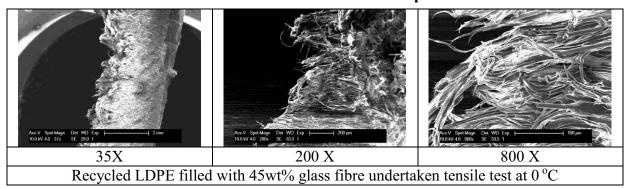
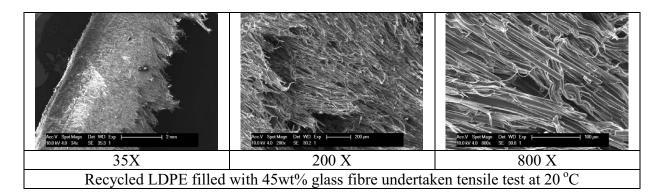
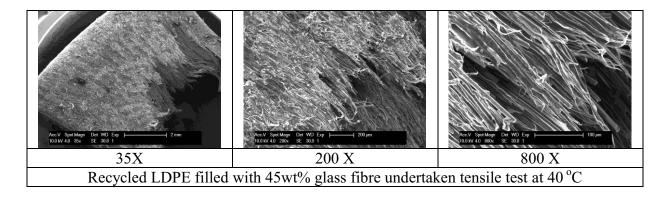
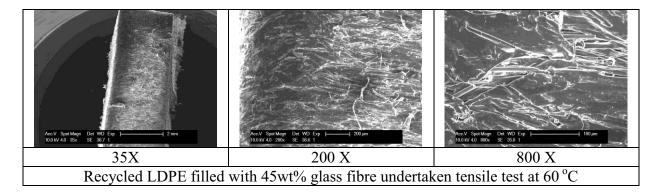
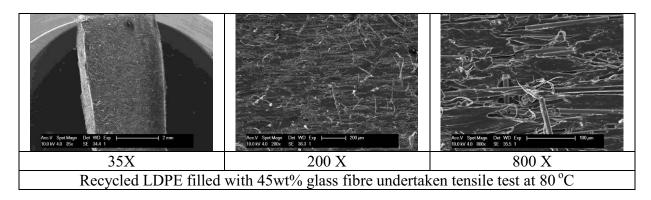
Table D-8 SEM photographs of recycled LDPE filled with 45wt% glass fibre undertaken tensile test at different temperatures

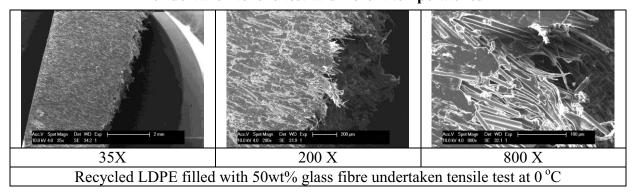
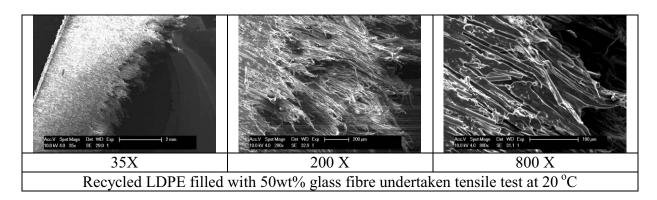
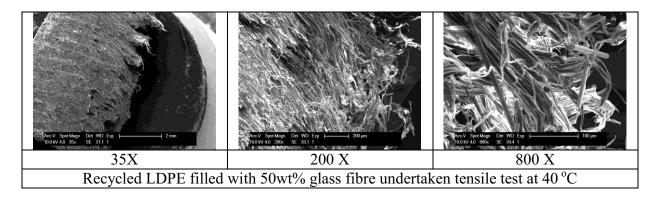
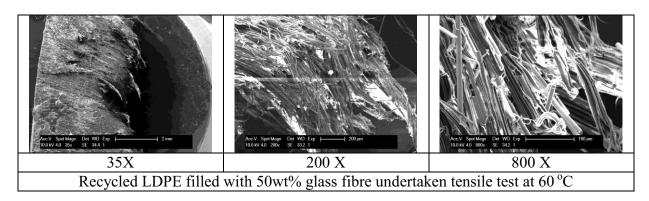
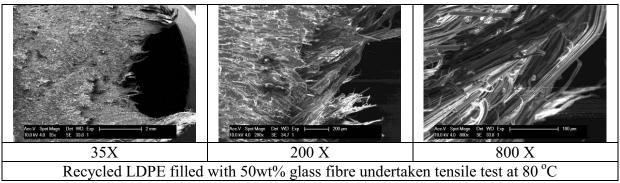
Table D-9 SEM photographs of recycled LDPE filled with 50wt% glass fibre undertaken tensile test at different temperatures
